# Research Summary – Evaluation and Analysis of Substandard Lithium-Ion Batteries by UN 38.3 Testing

*Transportation of Dangerous Goods | Scientific Research Division*

**Report:** Evaluation and Analysis of Substandard Lithium Ion Batteries by UN 38.3 Testing (2022)

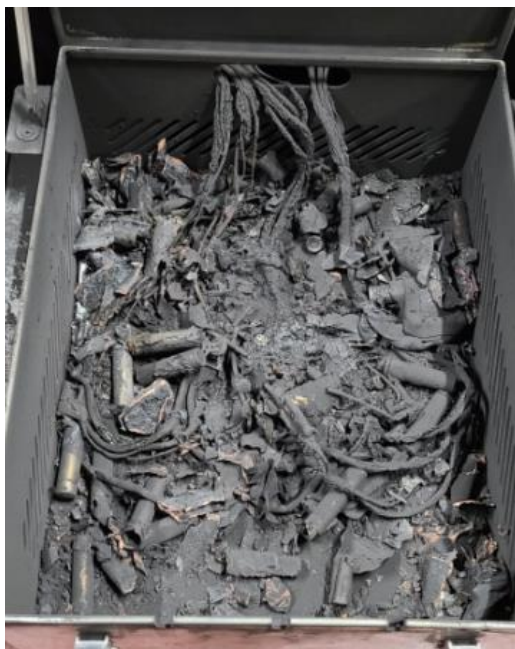
During fire and explosion failures of LiBs, it was typical to see a spike in voltage and a drop in current at the time of failure. Figure 1 shows batteries from B2 after the fire was extinguished and smoke was cleared, revealing the extent of the failure including the cells being charred or otherwise covered in debris.

*Figure 1. Results of fire and explosion of a B2 battery during T.7 Overcharge Testing*

twenty third-party LiB sets tested failed during UN 38.3 Testing. Non-compliances were found during T.3 – Vibration Testing, T.5 – Short Circuit Testing, and T.7 Overcharge Testing. Sets that failed T.5 and T.7 tended to result in fire and explosion events.
